**Supplemental File A:**  
**Compilation of field based offset measurements**

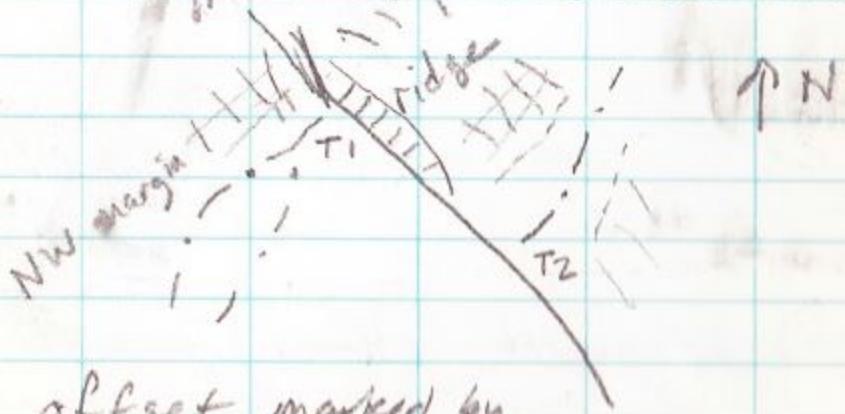
RCN 12 immedi. NW of  
offset channel crater site.  
10:28 a.m.

offset channel  $4.50 \pm 2.0$  m

offset marked by  
- poles in photos  
feature is line @ intersect  
of channel margin and thalweg  
downstream channel broad - flat  
- shelter ridge w/ splay on NW  
channel is ~1 m deep and  
ridge on NW of it is ~1 m  
deep

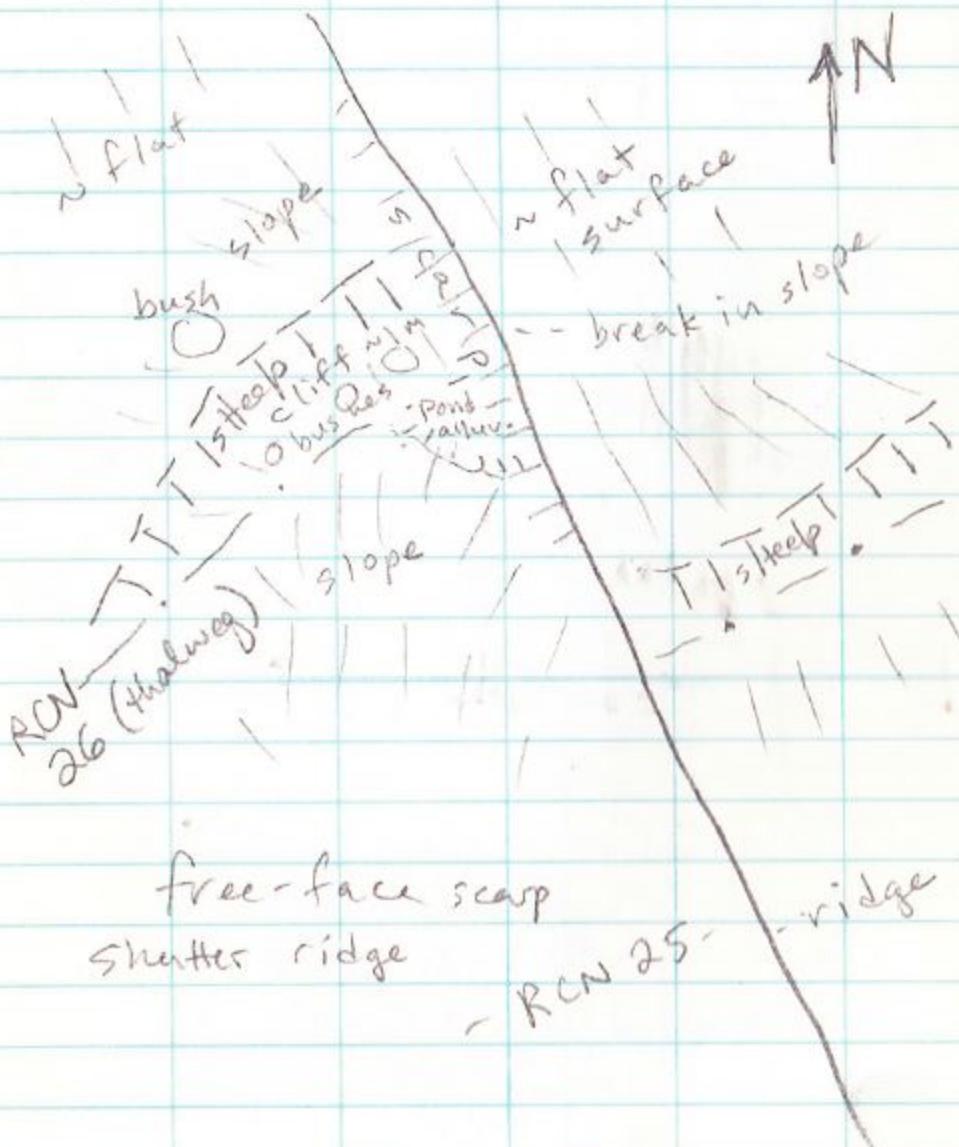
RCN 25  
3.7 m +/- 0.5 m

south  
piercing point

north piercing point

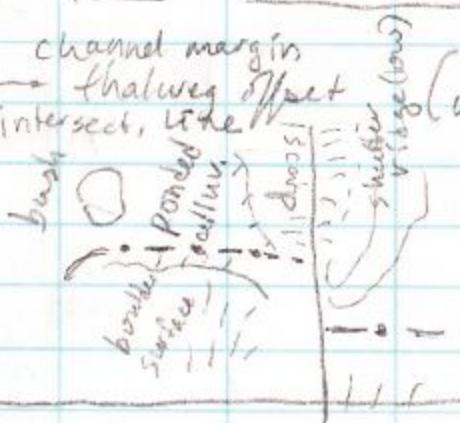
RCN 21 → channel margin  
thalweg offset (Frank lit)  
intersect, NNE (with GeoxH)

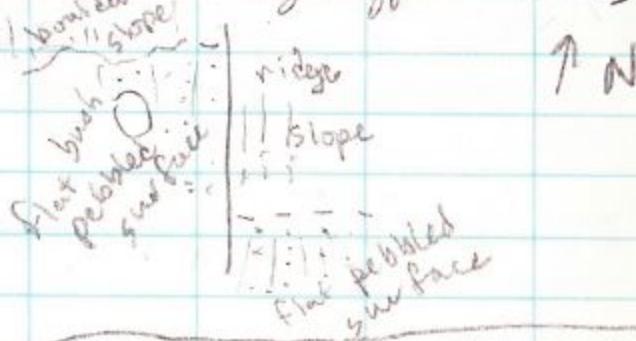
RCN 22 - channel margin offset (ditto)

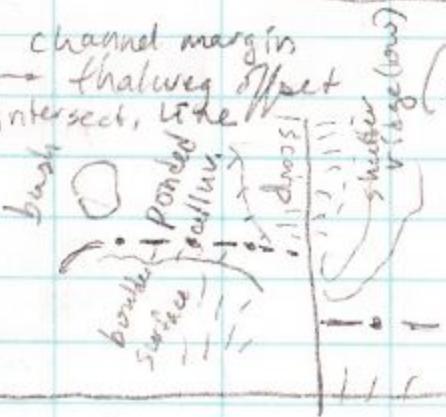
RCN 21 → channel margin  
thalweg offset (Frank lit)  
intersect, NNE (with GeoxH)

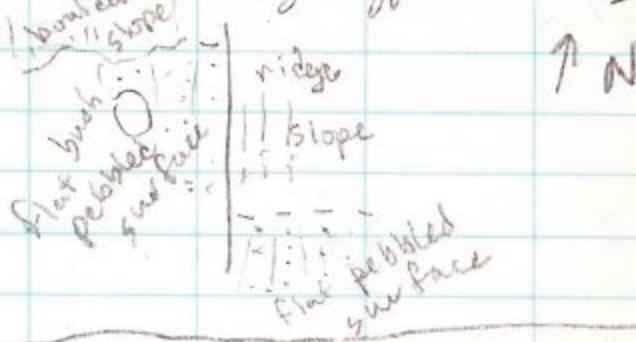
RCN 22 - channel margin offset (ditto)

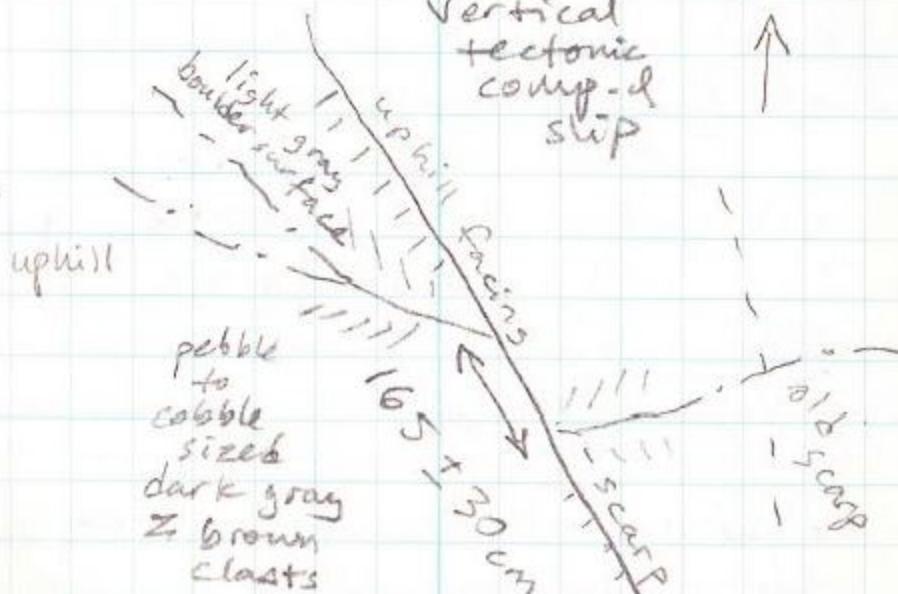
along fault in-plane "RCN1"  
→  $165 \pm 30$  cm r.d.

[plunge] (S end 15 cm lower than N end of tape) { but channel drops about 15 cm too }

no obvious vertical tectonic comp-d slip

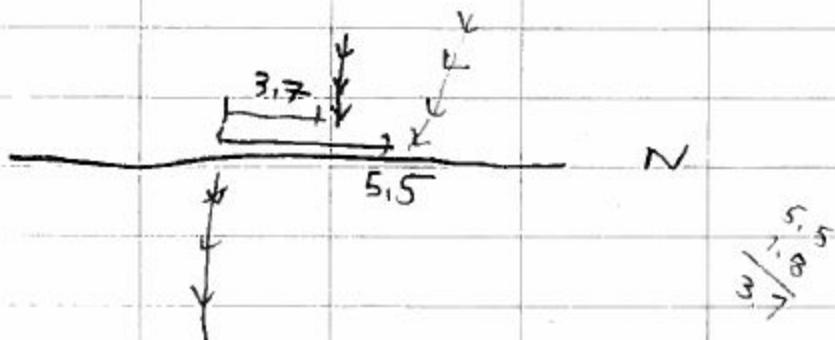
RCC7 = WP194

Feature A = small ch on flat hill slope

Max / best est tape = 5.5 m  $unc_{0.5}$

3.7 = measurement to small ch that could have been connected. But does not seem as good a match wrt shape (broader vs more V)

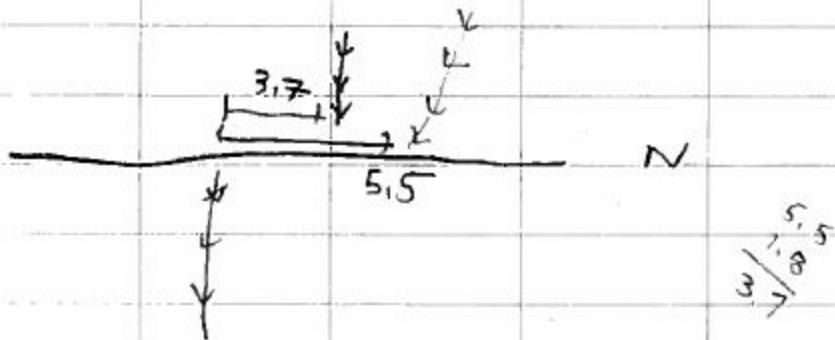
RCC 7 = WP194

Feature A = small ch on flat hill slope

Max / best est tape = 5.5 m  $unc_{0.5}$

3.7 = measurement to small ch that could have been connected. But does not seem as good a match wrt shape (broader vs more V)

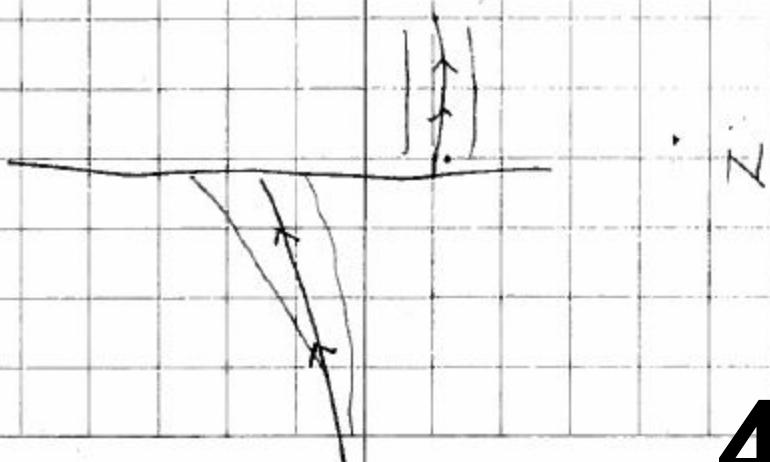
RCC7-chD  $WP = 195$

nice narrow ch on hill slope

tape 1st 3.3 +/- ~~0.7~~ 1.5

4.9 +/- max

1.4 min

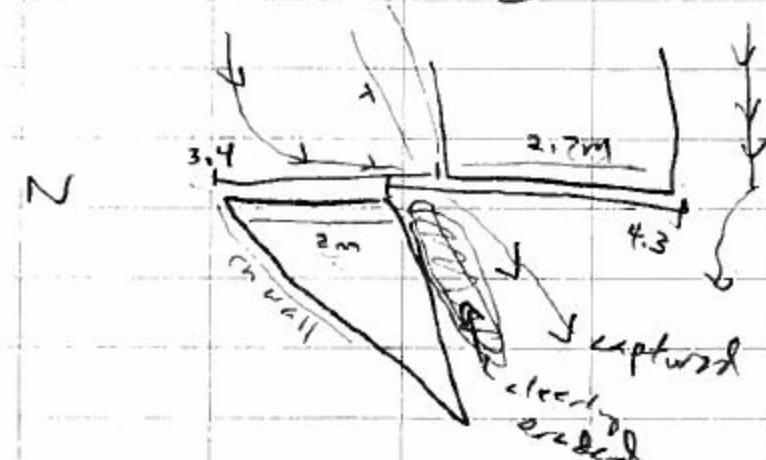
RCC6 - coll surface - B

3.4 = max b/c upstream side is cradled,  
of course downstream side too,

$$4.3 - 0.7 \text{ (diff in surface width)} = 3.6$$

$$3.4 = \text{prefred}, 3 \text{ max}, 0.7 \text{ min vs ch} = 2.7 - 3.4$$

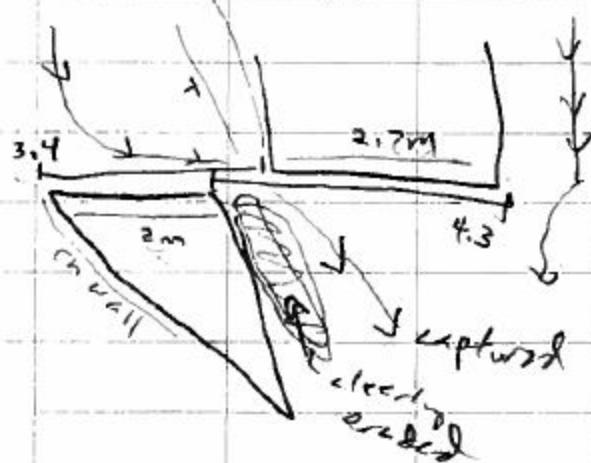
RCC6 - coll surface - B

short  
narrow  
shallow

3.4 = max b/fc upstream side is eroded,  
of course downstream side too,

$$4.3 - 0.7 \text{ (diff in surface width)} = 3.6$$

$$3.4 = \text{prefred, } 3 \text{ max, } 0.7 \text{ min vs un=}$$
$$2.7 - 3.4$$

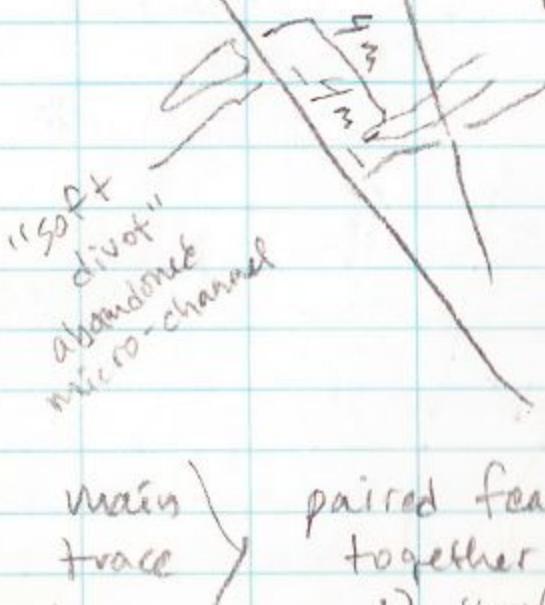
RCC 6 D

IGNORE!  
\* erroneous  
bad data!  
~~250 ± 100 cm~~  
secondary  
trace  
~~> 250 cm r.l.~~

\* → correct is 1.5 m  
secondary fault slip much less  
than 250 — we were  
by collapse on fracture  
min./max.

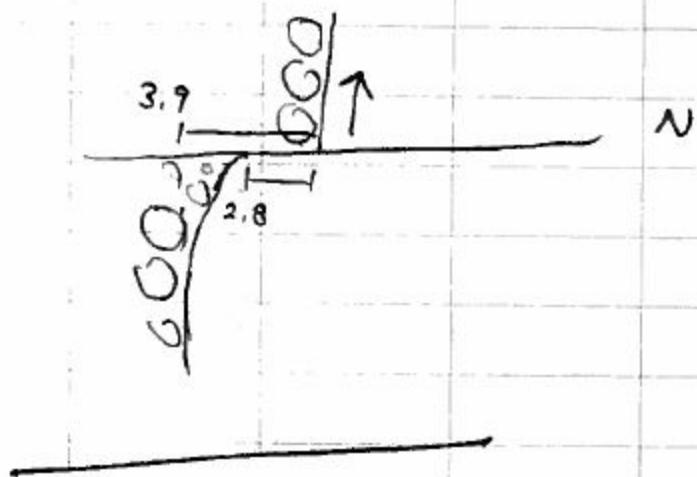
RCC2 = WP191 = 007 originates

2.8-3.8 topc, given boulder size,  
could be 2.8-3.8 or larger if  
down-stream edge eroded.

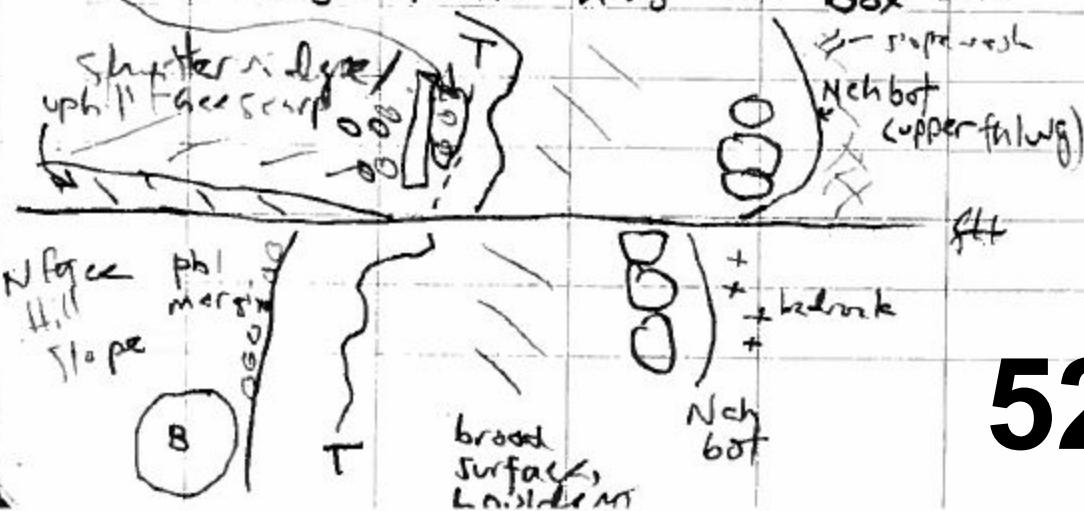
RCC3 - quick growth of narrow ch,  
S ch well, and N edge of terrace  
that Kent Frank measured

RCC4 - multiple ~3.9  $\times$  8.7. any measurement has 1 m box error

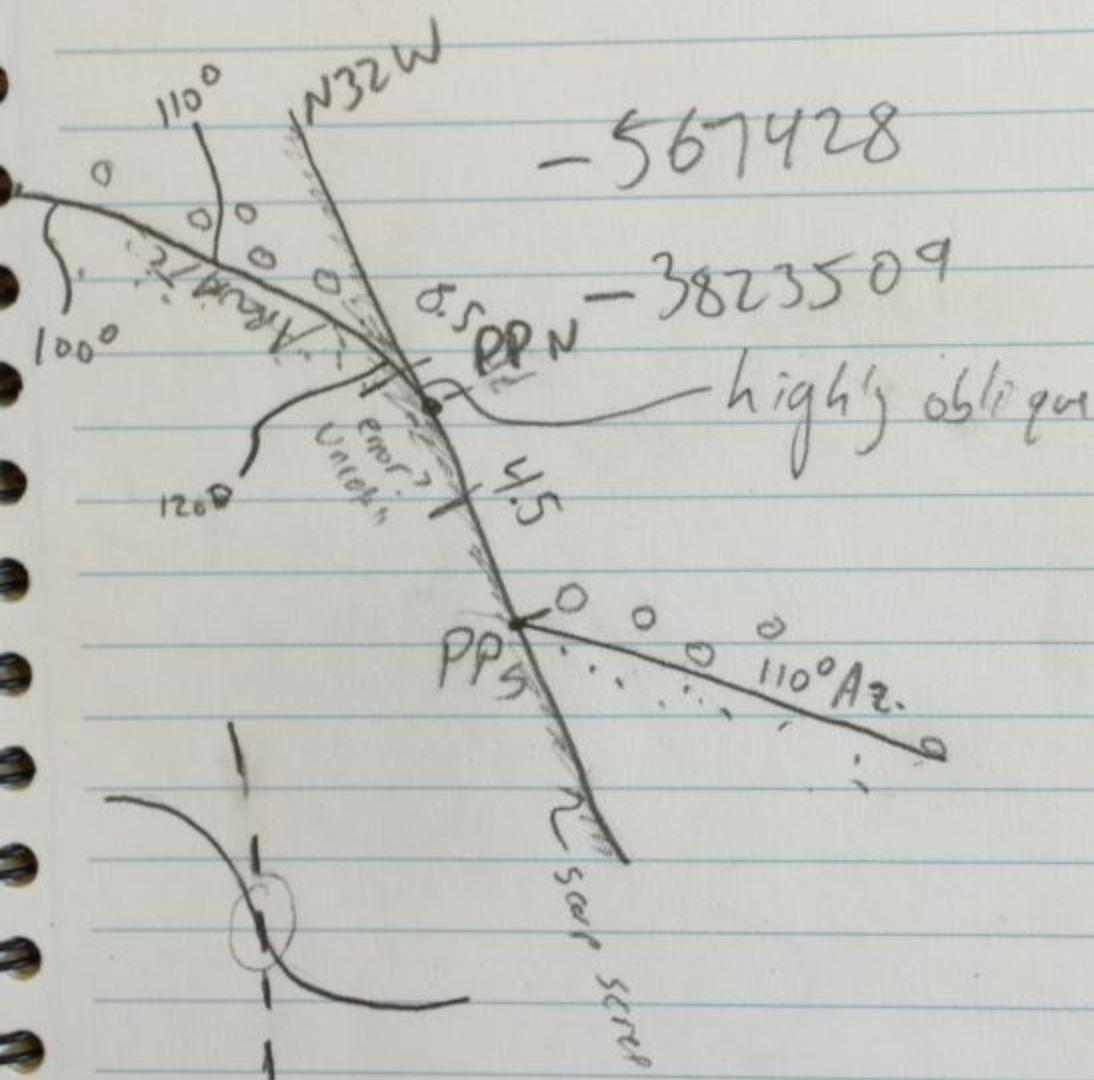
006 from yule et al

Location of CT 6.6 m  
measured.

Difflusing scree slope on fault reduces ability  
to precisely locate PPN which is not  
straight (it is bending)

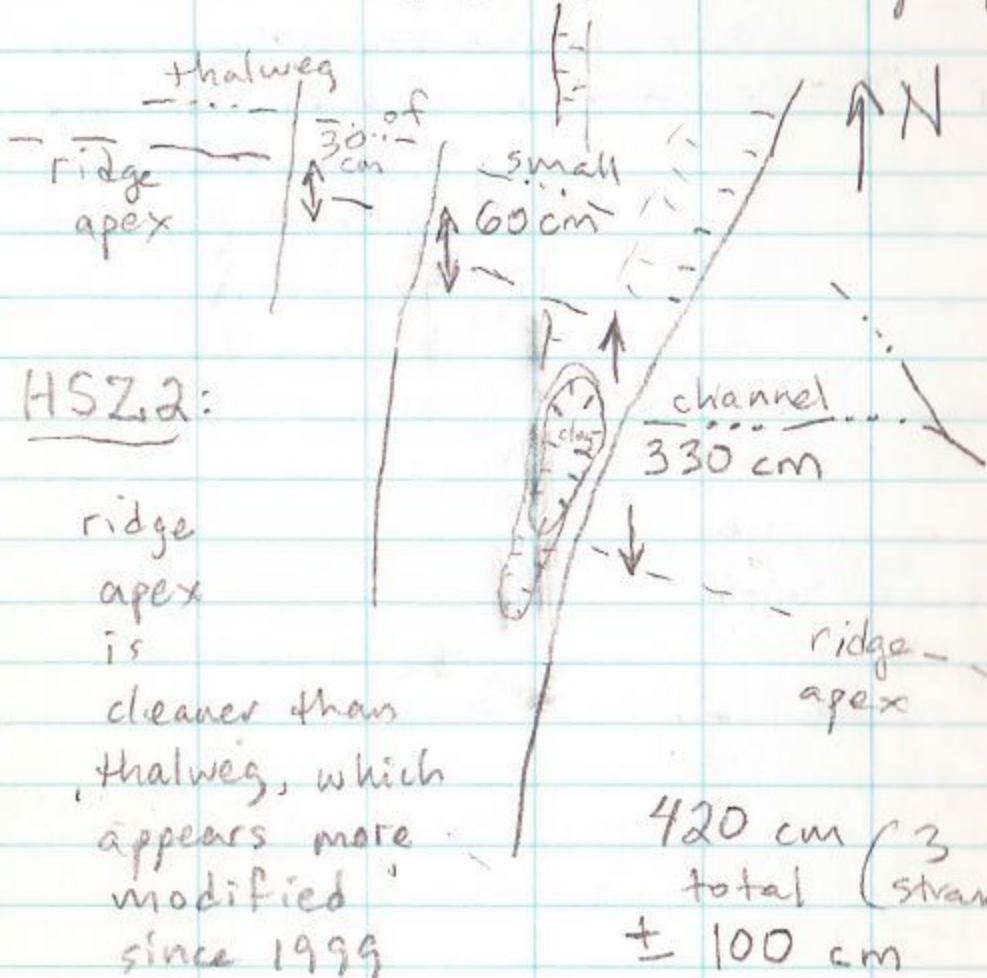
small ridge line offset across 3 strands  
and subtle channel on N side of ridge

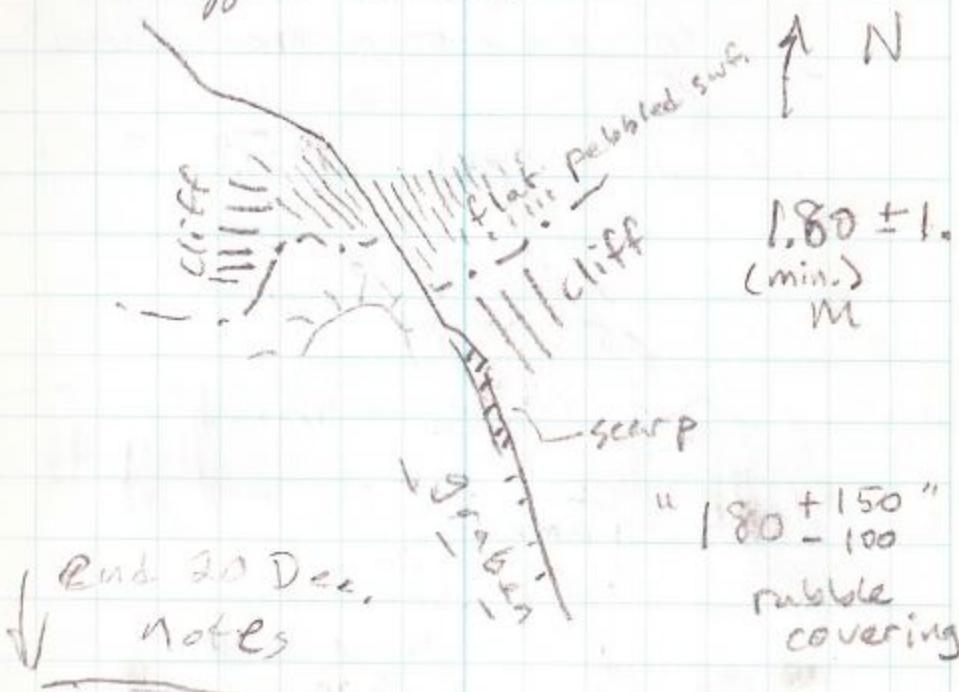
RCN13 - @ Trainor et al. point  
offset channel
